Technical Inspection Report
Bureau of Ordnance Group

6
OPERATION CROSSROADS.

TESTS 'A' AND 'B'.
VOLUME IV.
PART X. PHOTOGRAPHIC
APPENDIX [U].

GUNS AND MOUNTS PHOTOGRAPHIC INDEX

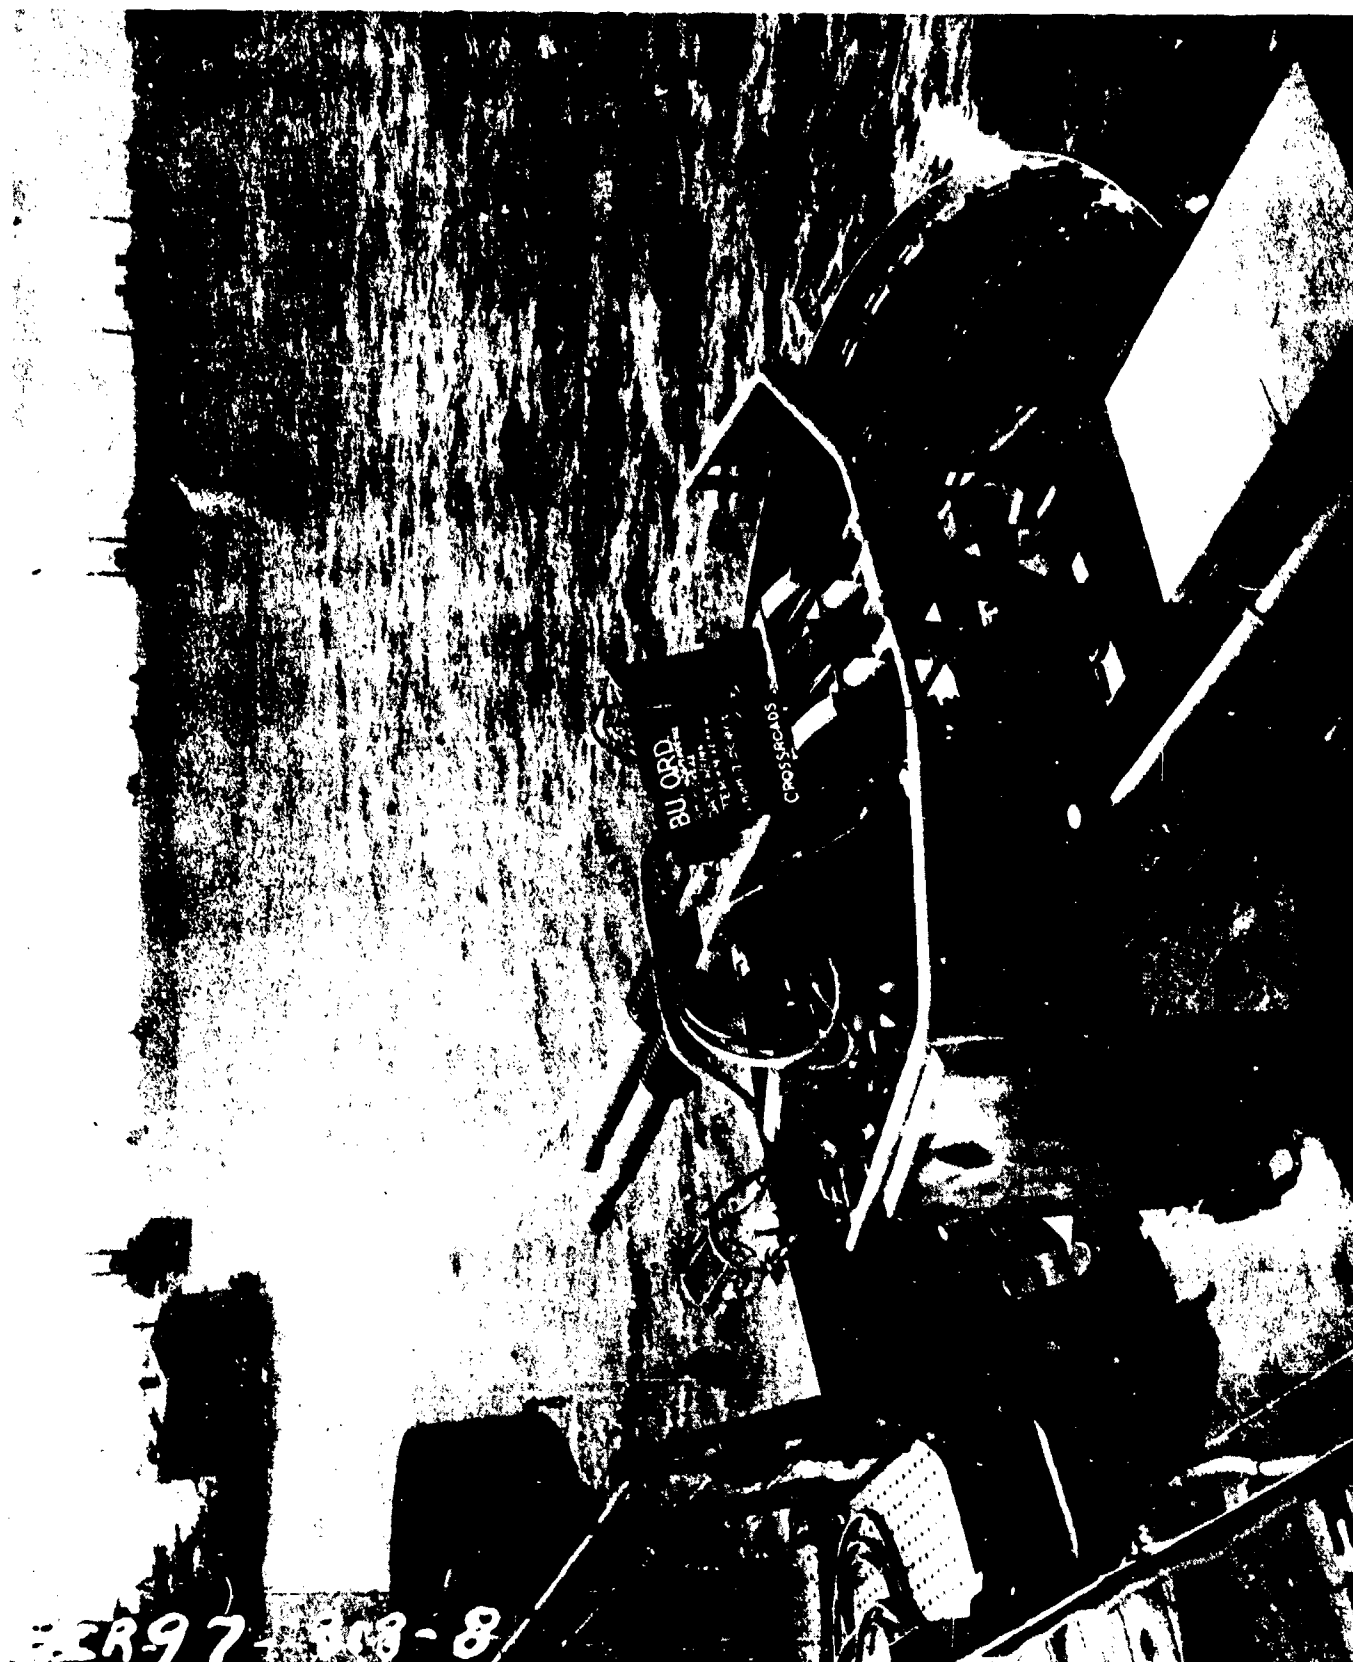
U.S.S. INDEPENDENCE (CVL-22) - Before Able
Condition of No. 9 40 MM Mount before Test "A".
Photo. No. BA-CR-97-31-E.

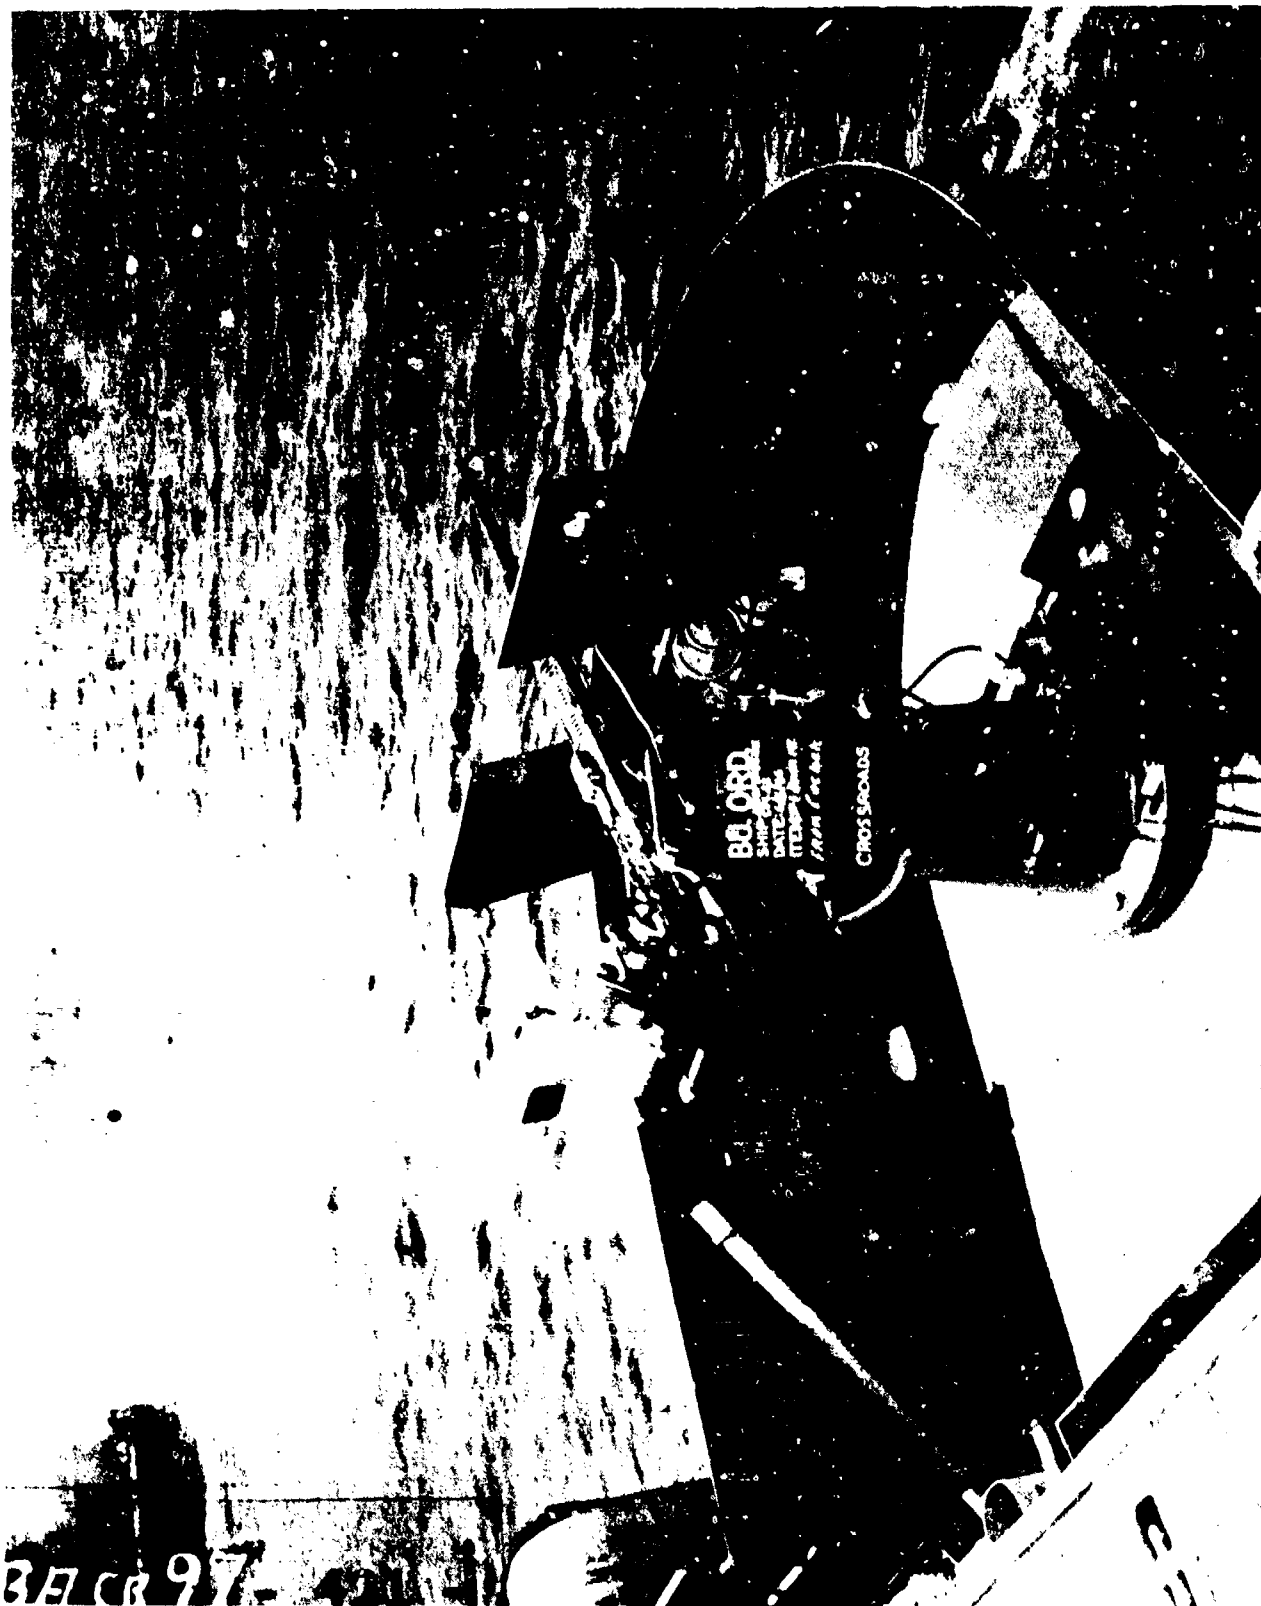
U.S.S. INDEPENDENCE (CVL-22) - Before Able
Condition of No. 1 20 MM Mount before Test "A".
Photo. No. BA-CH 97-421-1.

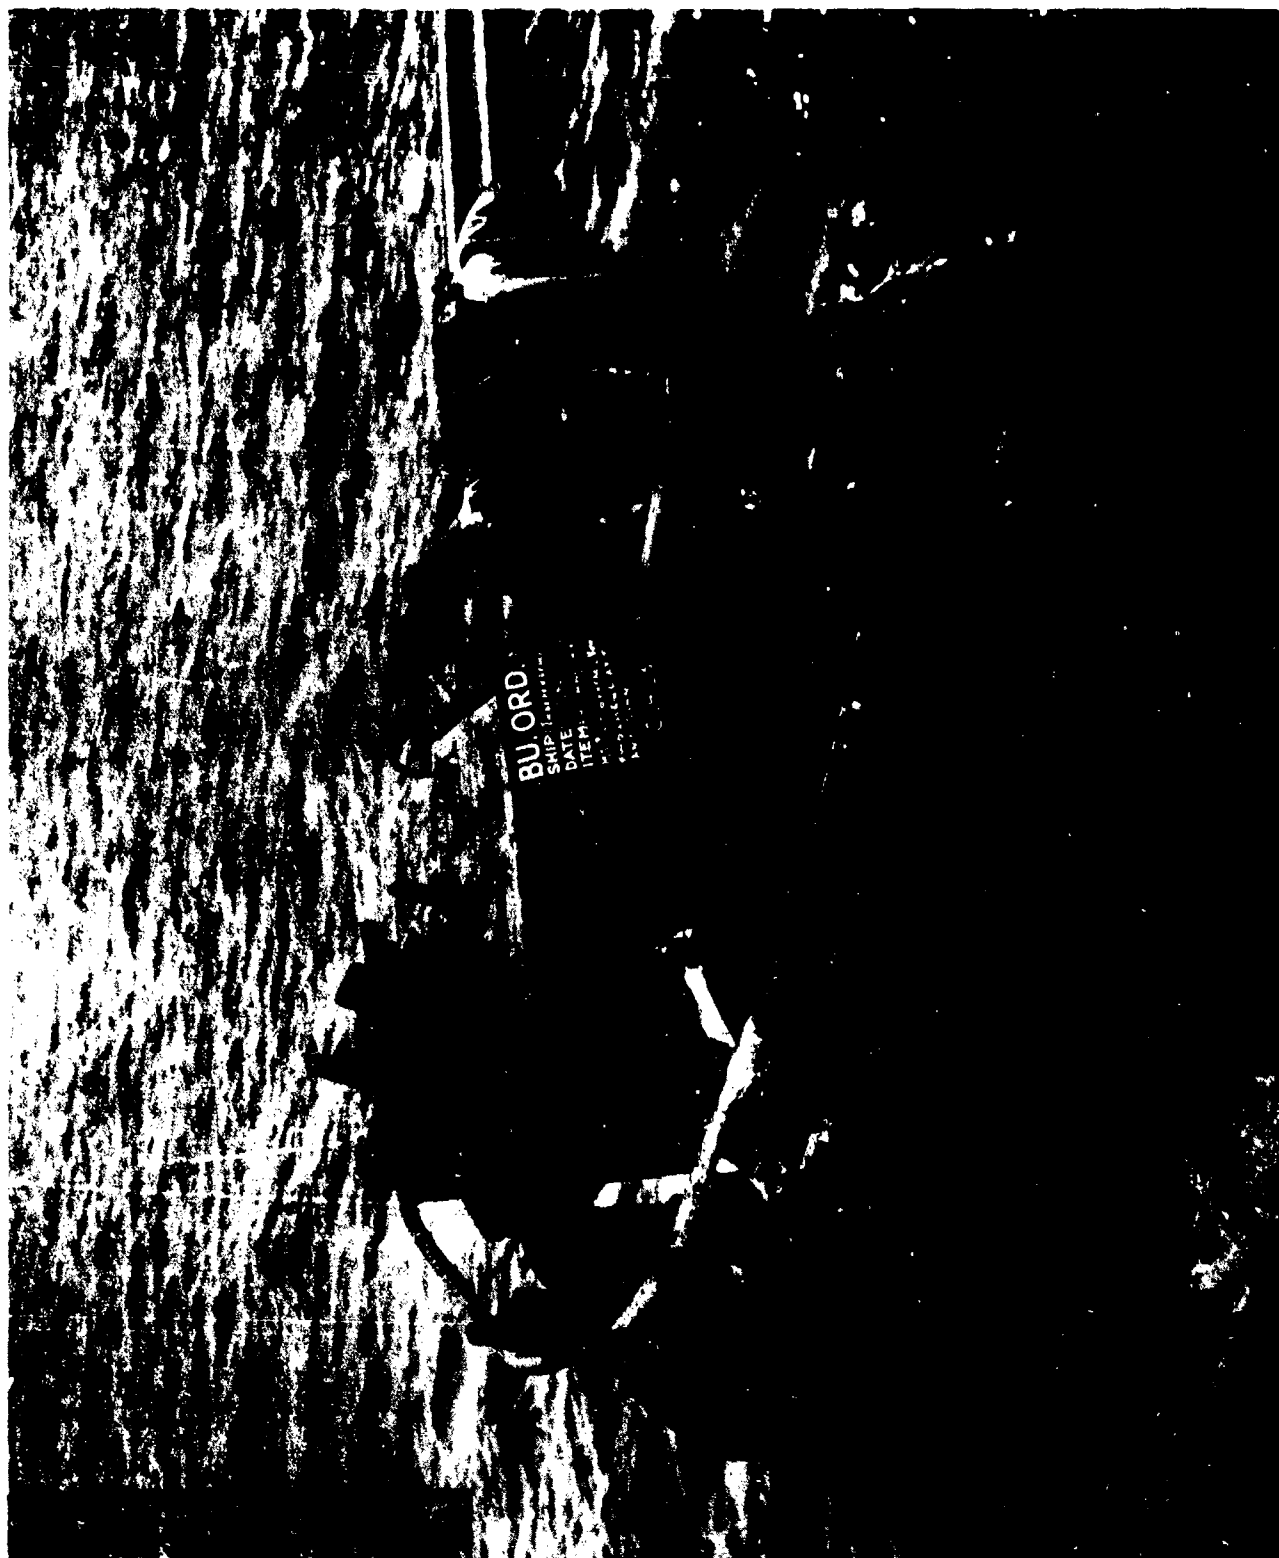
U.S.S. INDEPENDENCE (CVL-22) - After Able
View of the sheared off elevating locking
pin of 40 MM twin Mt. No. 2. This view was
taken from the left rear.
Photo. No. AA-81-1669-10.

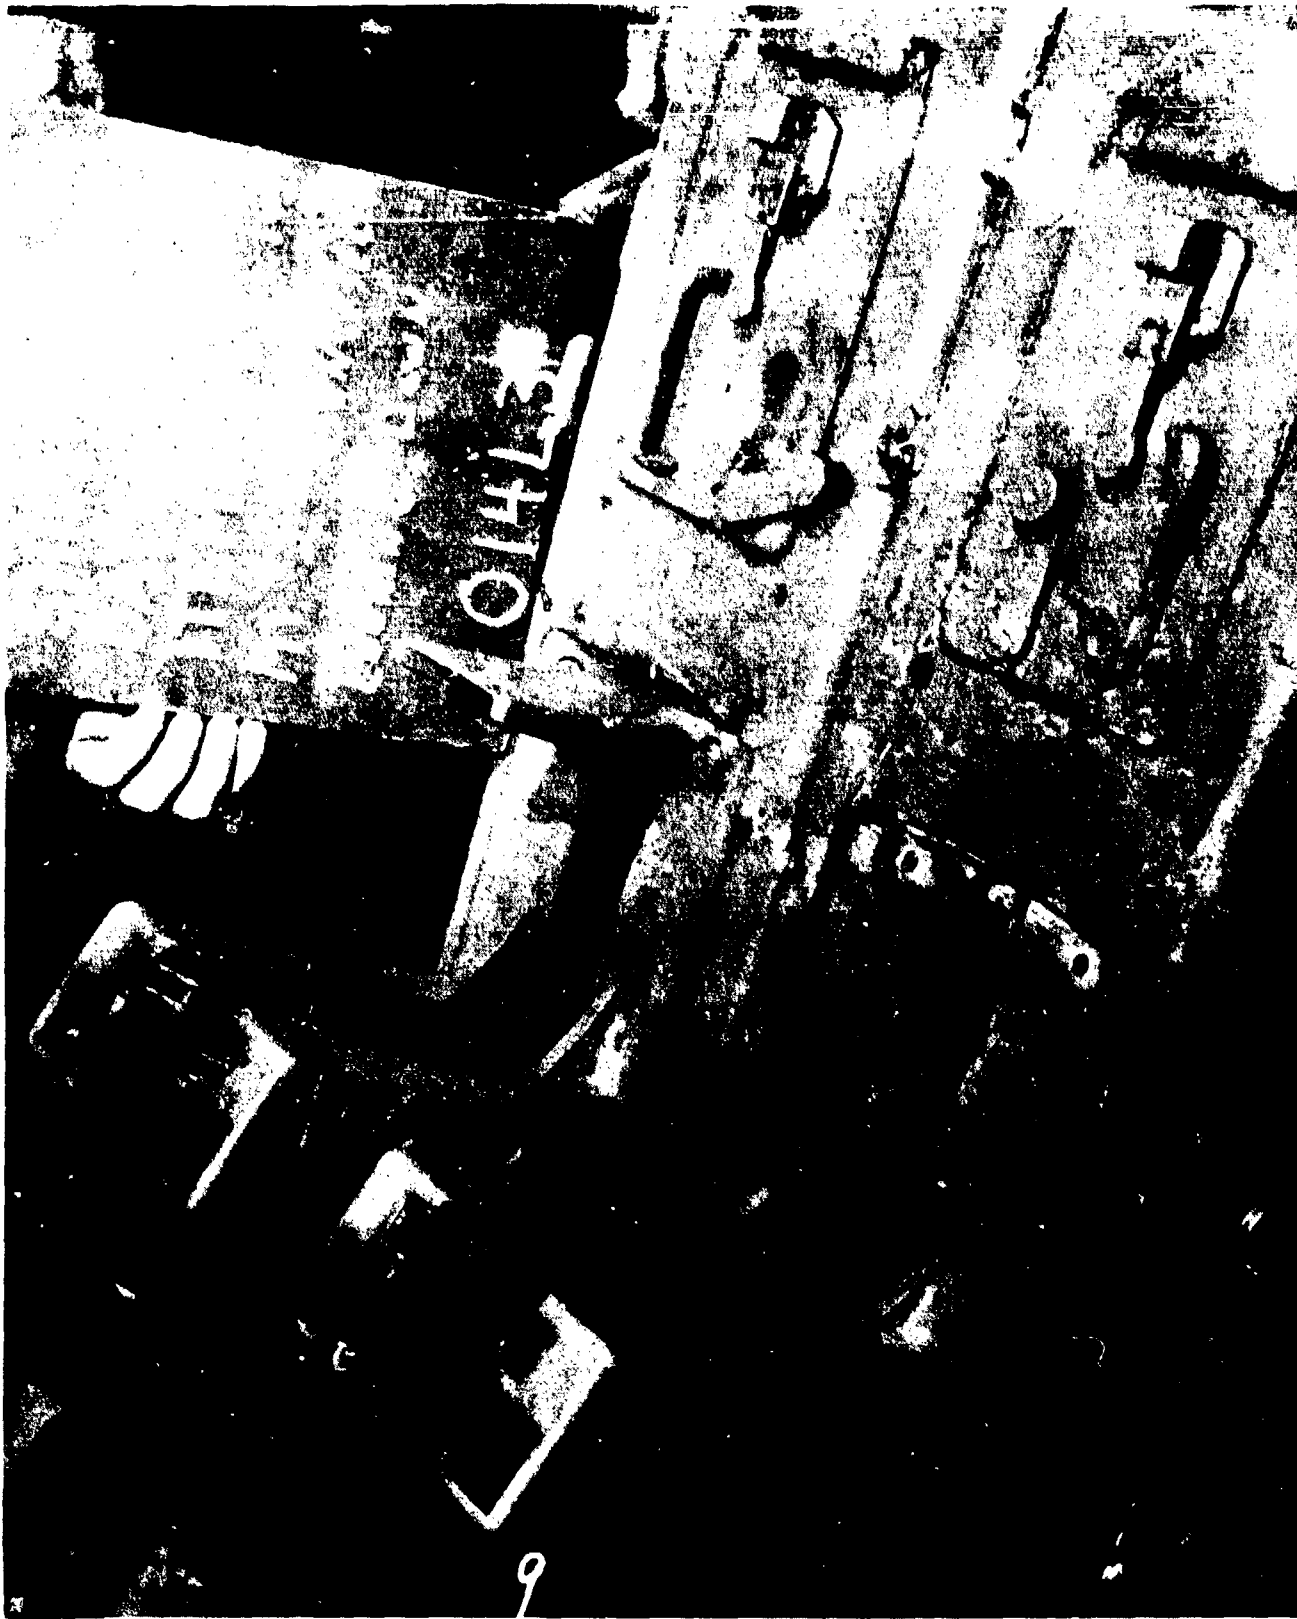
U.S.S. INDEPENDENCE (CVL-22) - After Able
 General view of 40 MM Twin Mt. No. 2
 Showing the damaged pointers open sight and
 the distorted Guard Rail Trainer's Side.
 Photo. No. AA-CR-81-1669-12.

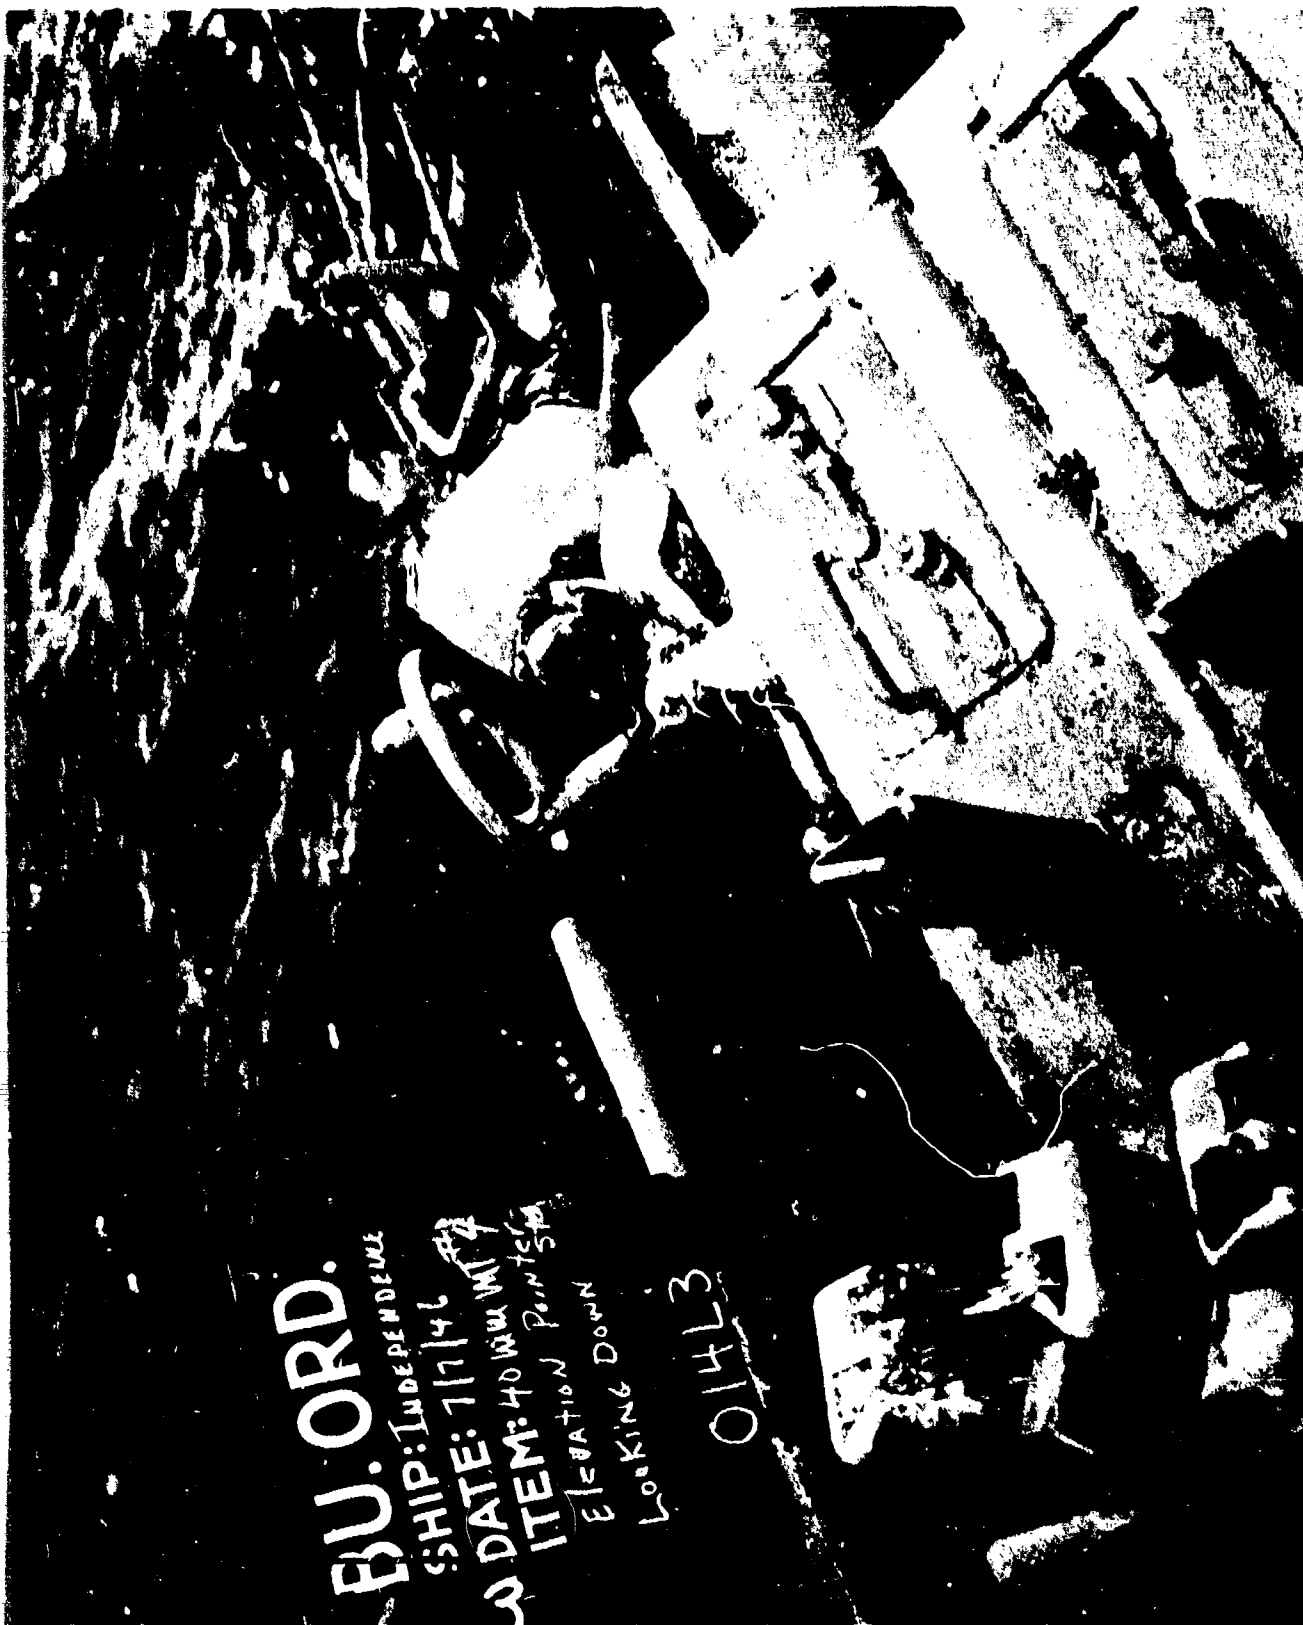
FF-01-81-167-5

BU. ORD. INDEPENDENCE (CVL-31) - 7/7/46 - 01473.
 Close up of 40 WU M. No. 2 showing the rent
 and ready service rack.
 (Photo No. FF-01-81-167-5).

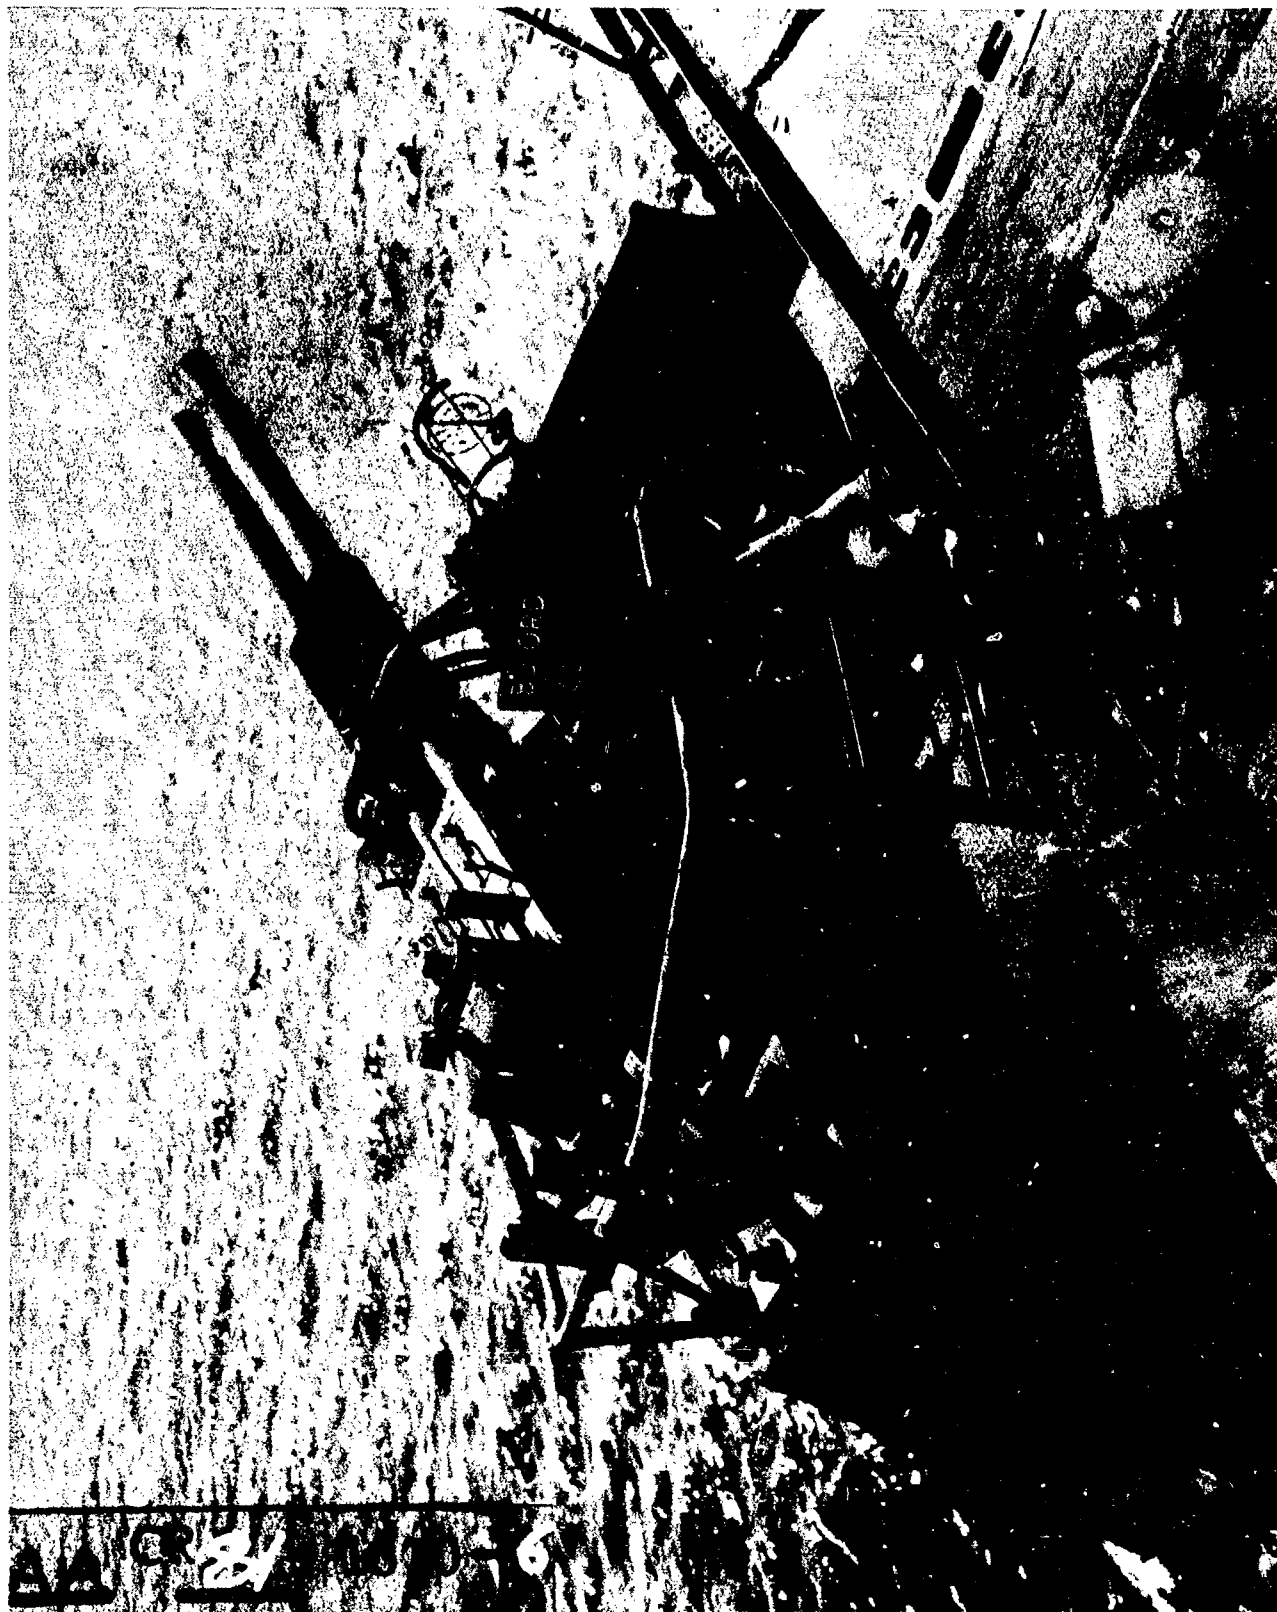
U.S.S. INDEPENDENCE (CVL-22) - After Attle
General view of 40 MM Twin Mt. No. 8 showing
the bent automatic loaders, the damaged open
sights and the distorted sponson shield.
Photo. No. AA-CR-81-1670-6.

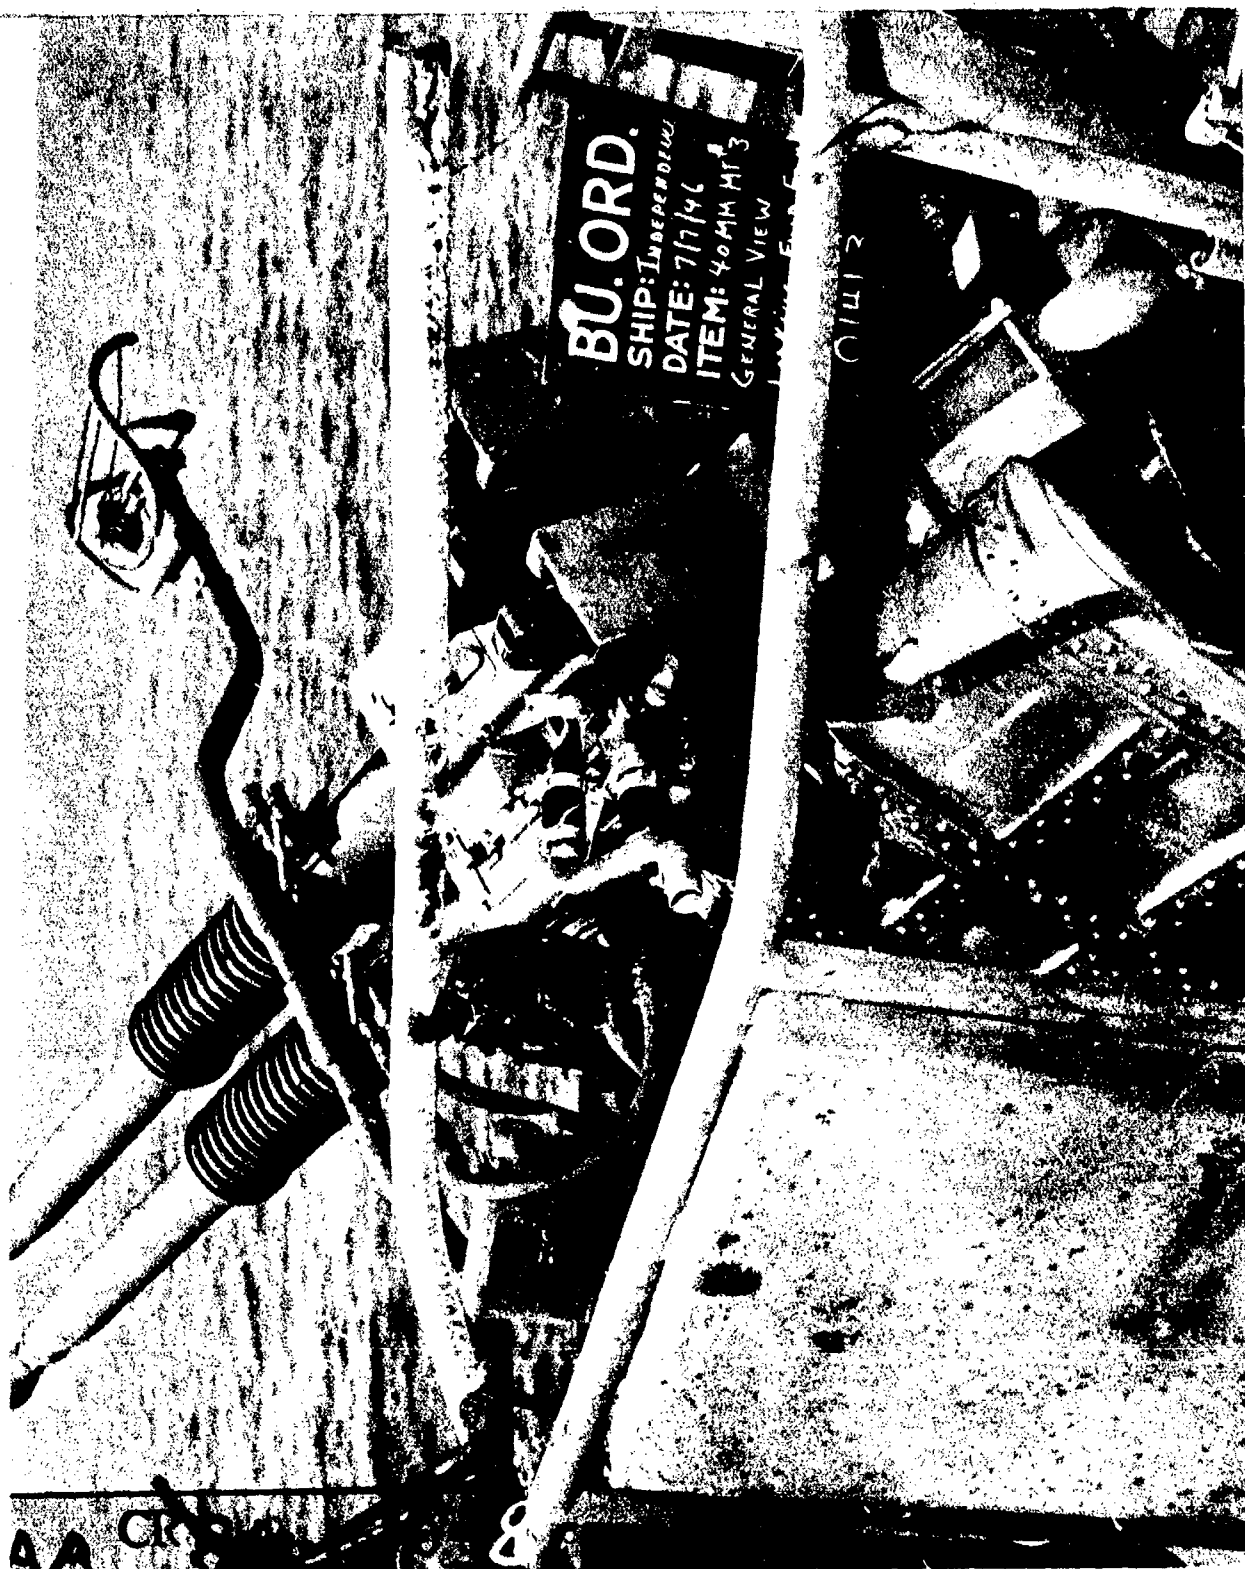
U.S.S. INDEPENDENT (C/L-22) - After 21.
General view of 40 mm twin St. No. 9 showing
the canted gun slice. An aircraft fuel tank
can be seen in the foreground. The white
pipe across the gun mechanism is a piece
of debris.
Photo. No. AA-CR-21-1070-8.

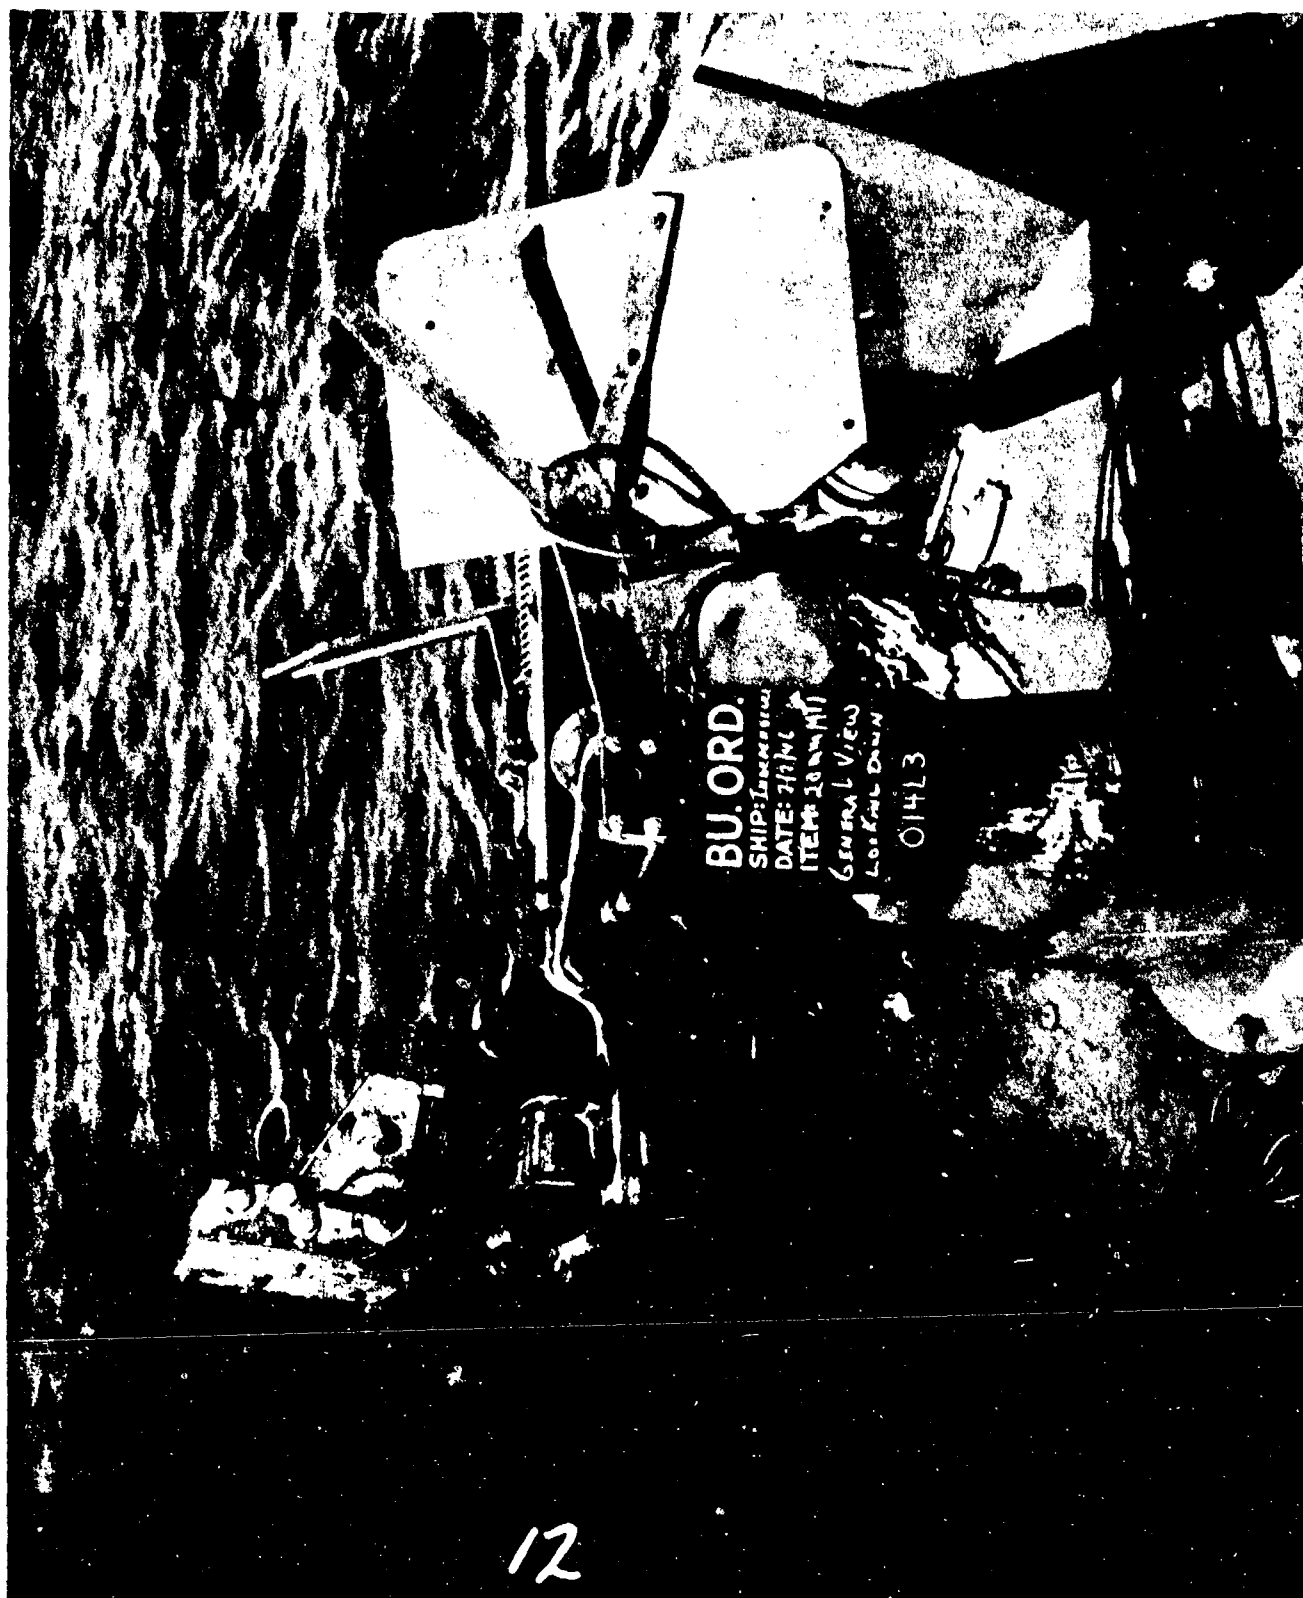
U.S.S. INDEPENDENCE (CVL-22) - After Able
General view of 20 mm Mt. No. 1 showing the
damage to the right splinter shield, cartridge
bag, Wk. 10 sight and missing shoulder rest.
Photo. No. AA-CP-81-1670-12.

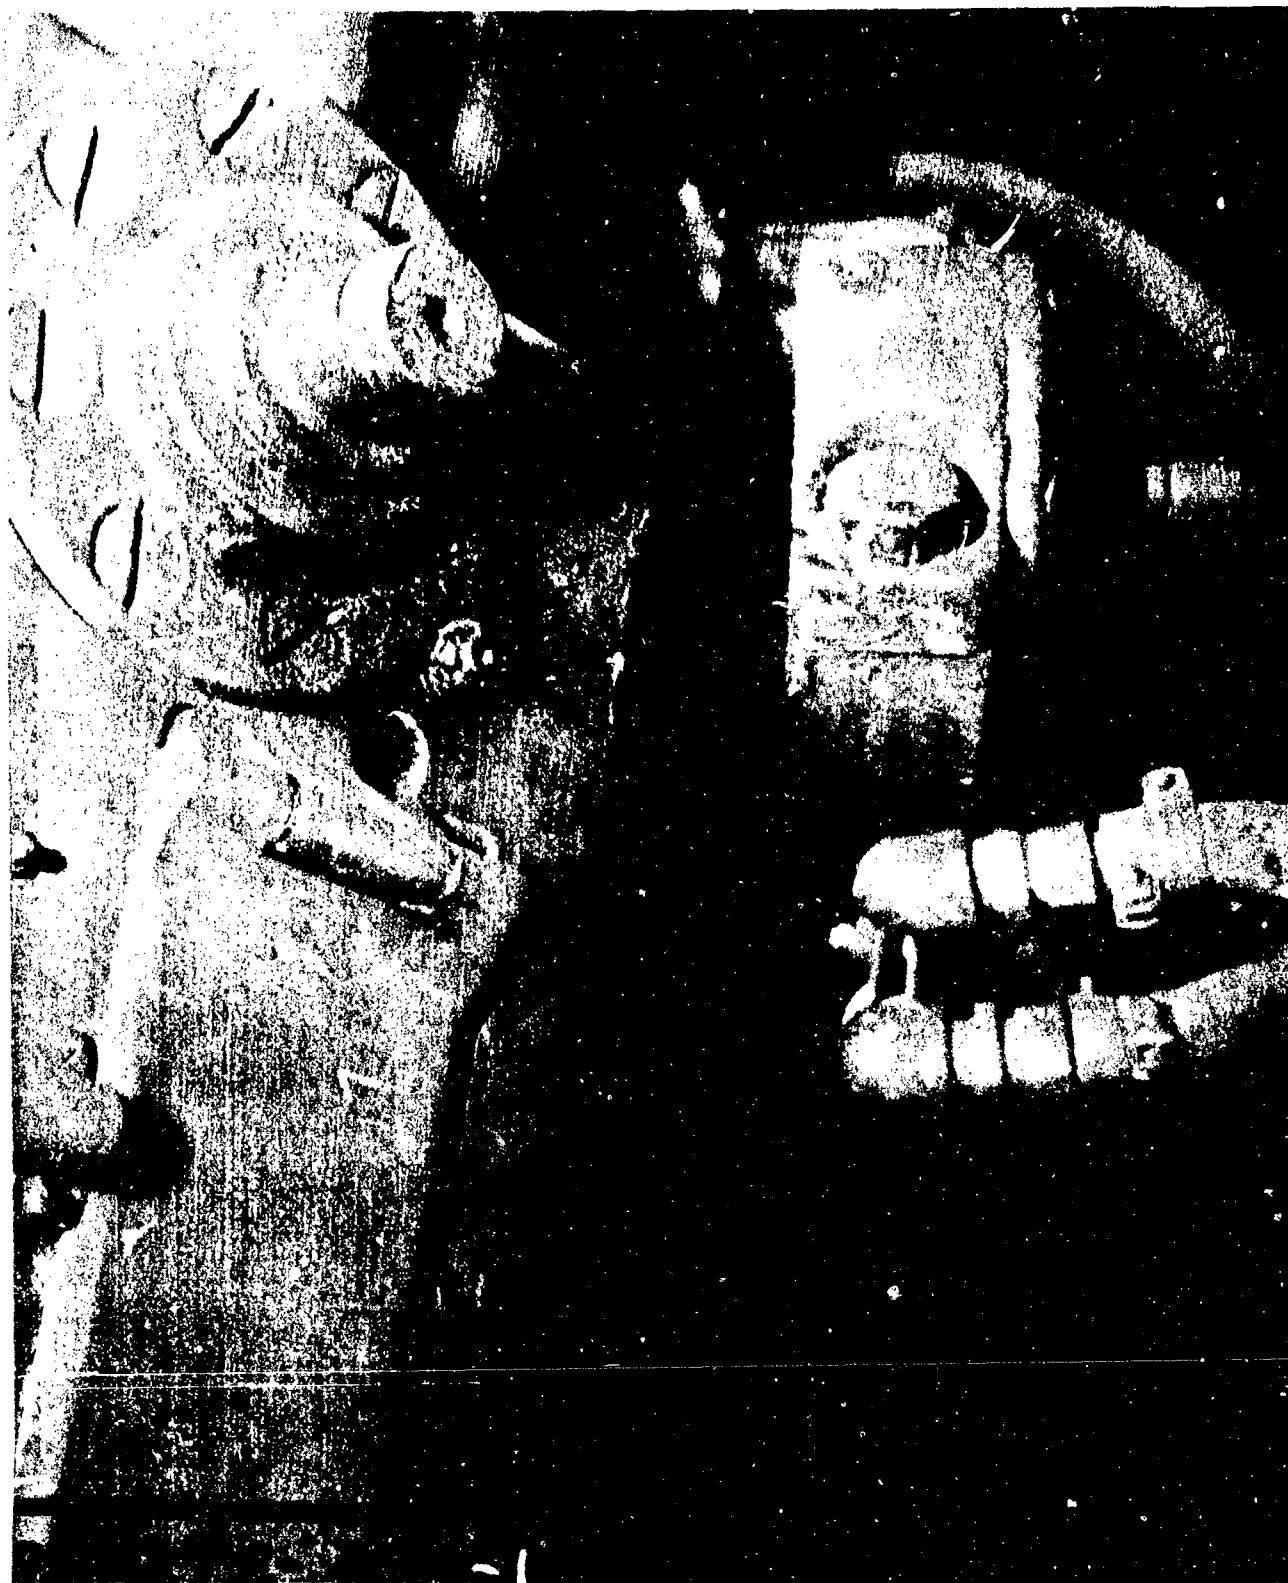
U.S.S. INDEPENDENCE (CVL-22) - After Able
View of 40 MM Twin Mt. No. 9 - looking
downward at the right trunnion and right
cap square. The displaced elevating arc
can be seen in the background.
Photo. No. AA-CR-92-1780-1.

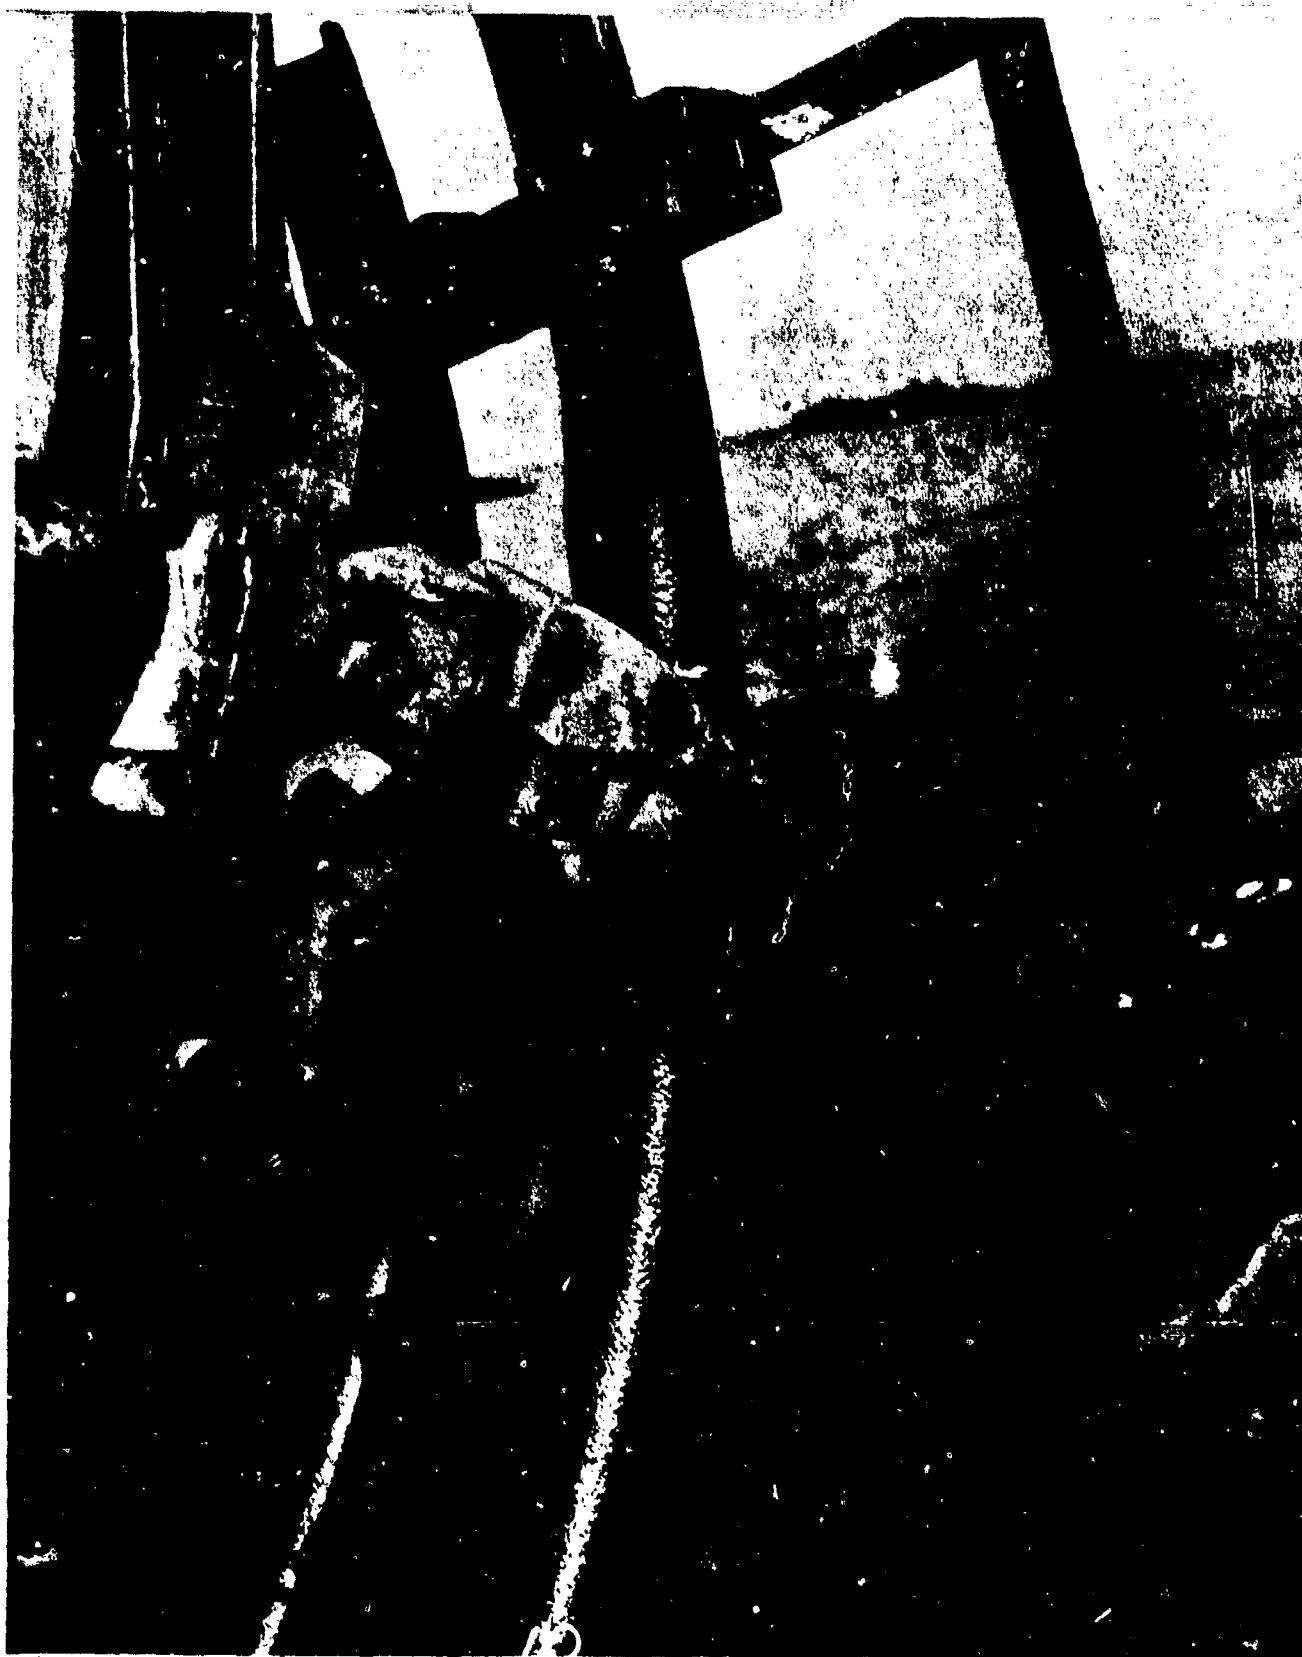
U.S.S. INDEPENDENCE (CVL-22) - After Able
Rear left view showing bent case ejecting
chute and the displaced case ejector.
Photo. No. AA-CR-92-1780-1. ZOMM Twin Mount No. 9.
